Window Condition Schedule & Photographs

Okehampton Town Hall,
Charter Hall &
Lower Market Hall

Window Condition Schedule

Survey Dates - 22nd March 2024 and 14th June 2024

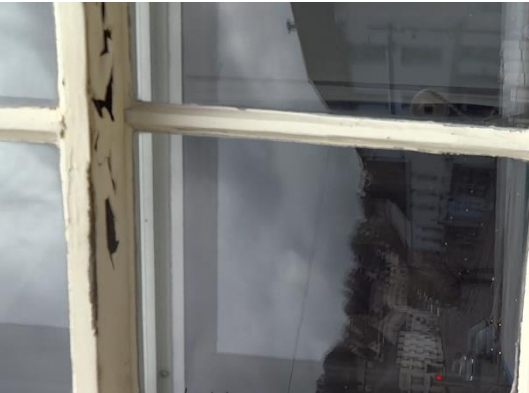
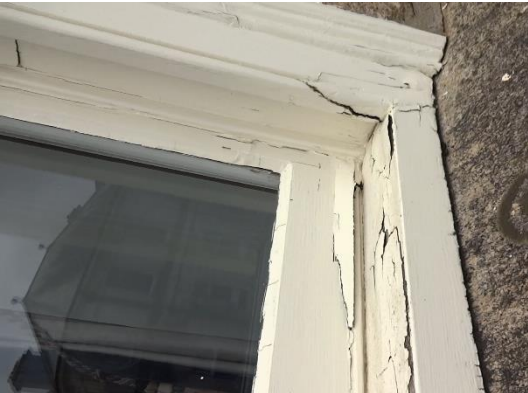
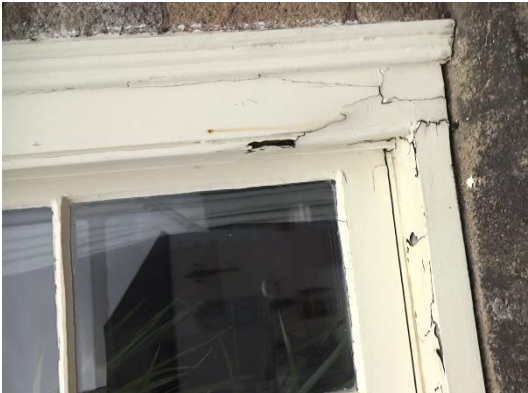
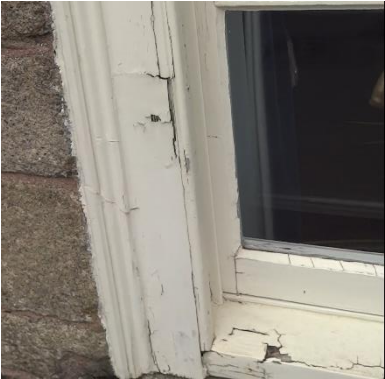
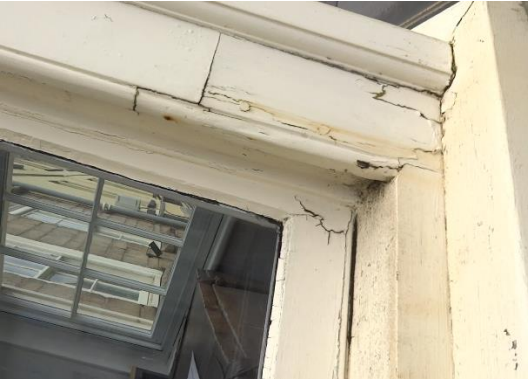
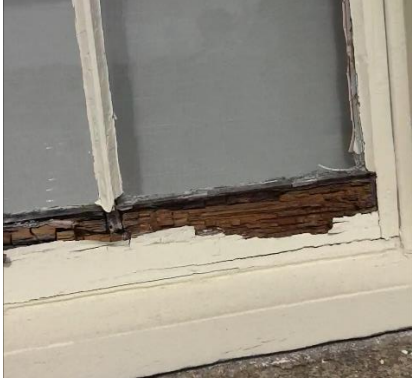
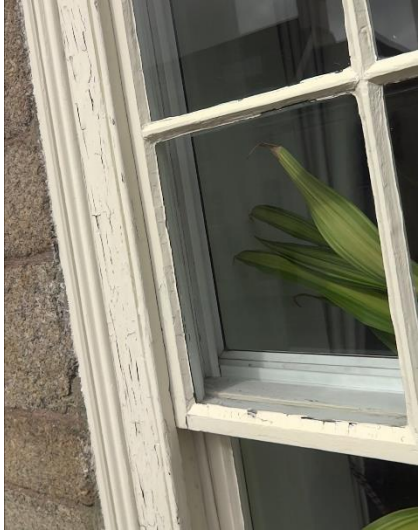
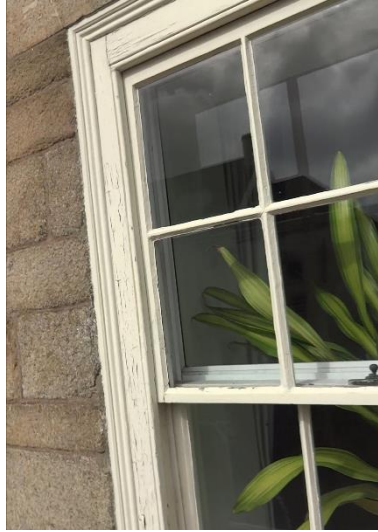
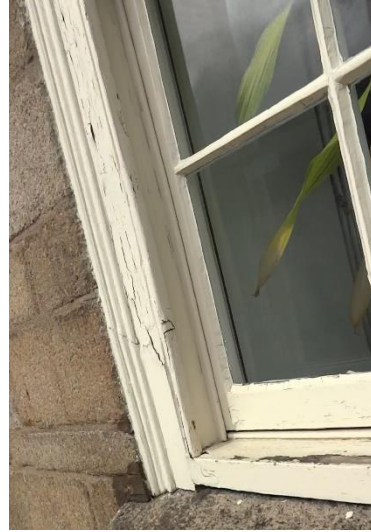
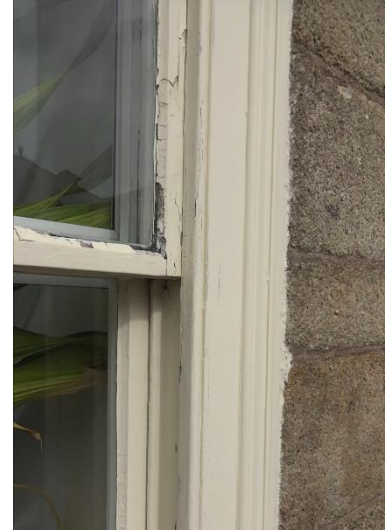
Windows 1-10 Condition

Window	Location	Type	Approx Age	Glazing	Frame Condition	Opening Mechanism/ Security	Priority
W01	Council Chamber	Timber Sliding Sash (Hornless)	1960s replacement	20th Century Single glazing (interior obscured by blinds)	Appear to be softwood frames. Frames in poor condition with significant external rot evident and evidence of previous repairs. Protective paint coating deteriorated and flaking.	Sash cords - Unable to view due to blinds	High
W02	Council Chamber	Timber Sliding Sash (Hornless)	1960s replacement	20th Century Single glazing (interior obscured by blinds)	Appear to be softwood frames. Frames in poor condition with significant external rot evident and evidence of previous repairs. Protective paint coating deteriorated and flaking.	Sash cords - Unable to view due to blinds	High
W03	Council Chamber	Timber Sliding Sash (Hornless)	1960s replacement	20th Century Single glazing (interior obscured by blinds)	Appear to be softwood frames. Frames in poor condition with significant external rot evident and evidence of previous repairs. Protective paint coating deteriorated and flaking.	Sash cords - Unable to view due to blinds	High

W04	Council Chamber	Timber Sliding Sash (Hornless)	1960s replacement	20th Century Single glazing (interior obscured by blinds)	Appear to be softwood frames. Frames in poor condition with significant rot evident and deteriorated frames. Protective paint coating deteriorated and flaking.	Sash cords - Unable to view due to blinds	Urgent
W05	Council Chamber	Timber Sliding Sash (Hornless)	1960s replacement	20th Century Single glazing (interior obscured by blinds)	Appear to be softwood frames. Frames in poor condition with significant external rot evident and evidence of previous repairs. Protective paint coating deteriorated and flaking.	Sash cords - Unable to view due to blinds	High
W06	Council Chamber	Timber Sliding Sash (Hornless)	1960s replacement	20th Century Single glazing, internal secondary glazing	Appear to be softwood frames. Frames in poor condition with significant external rot evident and evidence of previous repairs. Protective paint coating deteriorated and flaking.	Sash cords in situ, unable to test. Overpainted. Access not possible but assumed sash weights are present. Sash fitch fastener	High

W07	Council Chamber	Timber Sliding Sash (Hornless)	1960s replacement	20th Century Single glazing, internal secondary glazing	Appear to be softwood frames. Frames in poor condition with significant external rot evident and evidence of previous repairs. Protective paint coating deteriorated and flaking.	Sash cords in situ, unable to test. Overpainted. Access not possible but assumed sash weights are present. Sash fitch fastener	High

W08	Council Chamber	Timber Sliding Sash (Hornless) Bay Windows	1960s replacement	20th Century Single glazing, internal secondary glazing	Appear to be softwood frames. Frames in poor condition with significant external rot evident and evidence of previous repairs. Protective paint coating deteriorated and flaking.	Sash cords in situ, unable to test. Overpainted. Access not possible but assumed sash weights are present. Sash fitch fastener	High
W09	Council Chamber	Timber Sliding Sash (Hornless)	1960s replacement	20th Century Single glazing, internal secondary glazing	Appear to be softwood frames. Frames in poor condition with significant external rot evident and evidence of previous repairs. Protective paint coating deteriorated and flaking.	Sash cords in situ, unable to test. Overpainted. Access not possible but assumed sash weights are present. Sash fitch fastener	Urgent
W10	Council Chamber	Timber Sliding Sash (Hornless)	1960s replacement	20th Century Single glazing, internal secondary glazing	Appear to be softwood frames. Frames in poor condition with significant external rot evident and evidence of previous repairs. Protective paint coating deteriorated and flaking.	Sash cords in situ, unable to test. Overpainted. Access not possible but assumed sash weights are present. Sash fitch fastener	Urgent

W11	Reception	Timber Sliding Sash (Hornless)	1960s replacement	20th Century Toughened Single glazing, internal secondary glazing	Appear to be softwood frames. Frames in poor condition externally, rot evident to external sill and frames and evidence of previous splice repairs to base of frames. Protective paint coating deteriorated and flaking.	Sash cords removed. Sash fitch fastener.	High

W12	Reception	Timber Sliding Sash (Hornless)	1960s replacement	20th Century Toughened Single glazing, internal secondary glazing	Appear to be softwood frames. Frames in poor condition externally, rot evident to external sill and frames and evidence of previous splice repairs to base of frames. Protective paint coating deteriorated and flaking.	Sash cords removed. Sash fitch fastener.	High
W13	Wedding Room	Timber Sliding Sash (Hornless)	1960s replacement	20th Century Toughened single glazing	Appear to be softwood frames. Frames in poor condition externally, rot evident to external sill and frames and evidence of previous splice repairs to base of frames. Protective paint coating deteriorated and flaking.	Sash cords removed. Sash fitch fastener.	High
W14	Wedding Room	Timber Sliding Sash (Hornless)	1960s replacement	20th Century Toughened single glazing	Appear to be softwood frames. Frames in poor condition externally, rot evident to external sill and frames and evidence of previous splice repairs to base of frames. Protective paint coating deteriorated and flaking.	Sash cords removed. Sash fitch fastener.	High

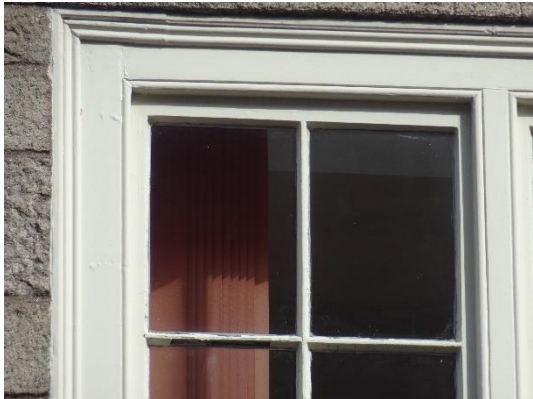
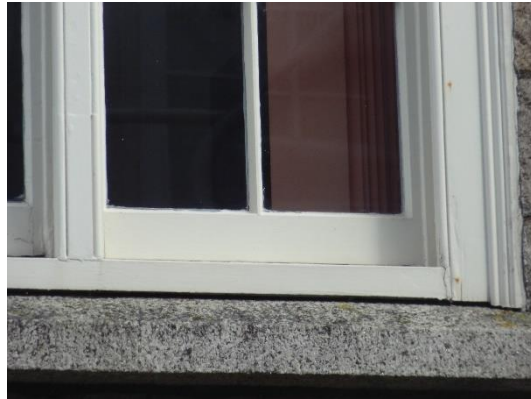
Window 20

W20	Council Chamber (Ante Room)	Timber Sliding Sash (Hornless)	1960s replacement	20th Century Single glazing	Appear to be softwood frames. Minor rot evident to external sill and frames and evidence of previous splice repairs to base of frames. Signs of water ingress internally. Protective paint coating deteriorated and flaking.	Sash cords in situ, unable to test. Overpainted. Access not possible but assumed sash weights are present. Sash fitch fastener	Med

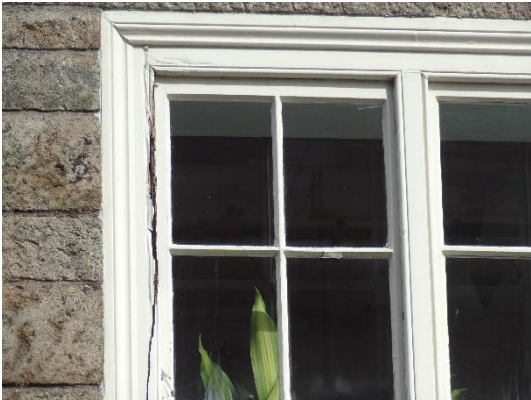
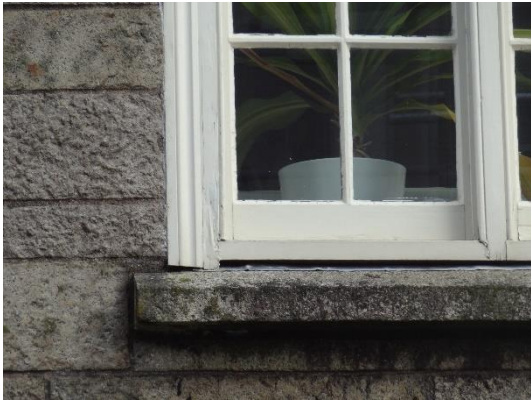
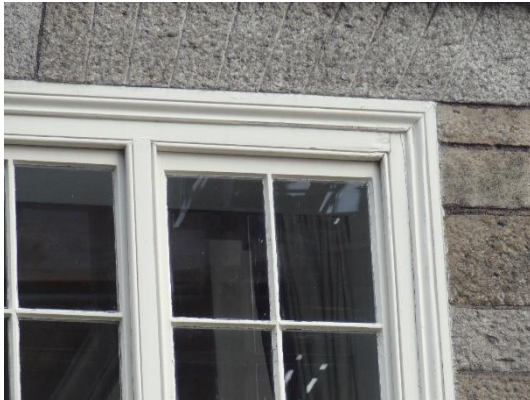
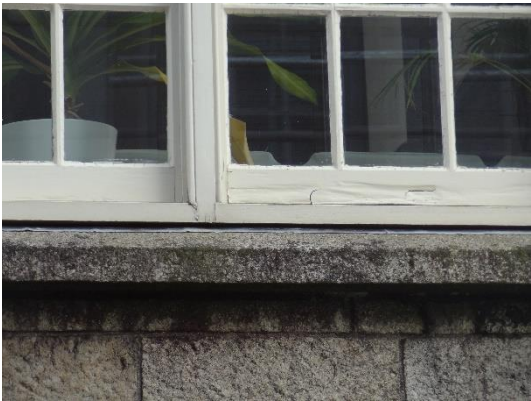
Window 21

W21	Council Chamber	Timber Sliding Sash (Hornless)	1960s replacement	20th Century Single glazing, internal secondary glazing	Appear to be softwood frames. Frames in poor condition with significant external rot evident and evidence of previous repairs. Protective paint coating deteriorated and flaking.	Sash cords in situ, unable to test. Overpainted. Access not possible but assumed sash weights are present. Sash fitch fastener	Urgent
W22	Town Clerk's office	Timber Sliding Sash (Hornless)	1960s replacement	20th Century Toughened Single glazing, internal secondary glazing	Appear to be softwood frames. Minor rot evident to external sill and frames and evidence of previous splice repairs to base of frames. Signs of water ingress internally. Protective paint coating deteriorated and flaking.	Sash cords removed. Sash fitch fastener.	Med
W23	Office	Timber Sliding Sash (Hornless)	1960s replacement	20th Century Toughened Single glazing, internal secondary glazing	Appear to be softwood frames. Minor rot evident to external sill and frames and evidence of previous splice repairs to base of frames. Signs of water ingress internally. Protective paint coating deteriorated and flaking.	Sash cords removed. Sash fitch fastener.	Med

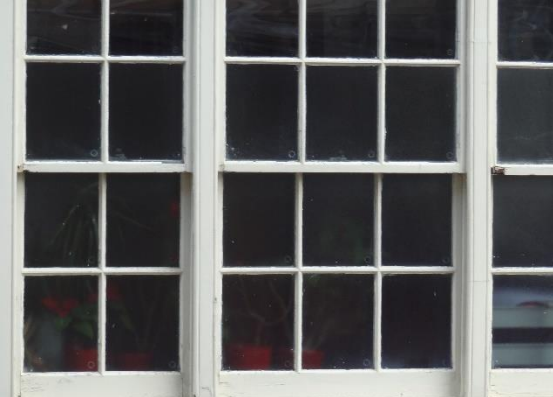
Windows 22-24

W24	Reception	Timber Sliding Sash (Hornless)	1960s replacement	20th Century Toughened Single glazing, internal secondary glazing	Appear to be softwood frames. Minor rot evident to external sill and frames and evidence of previous splice repairs to base of frames. Signs of water ingress internally. Protective paint coating deteriorated and flaking.	Sash cords removed. Sash fitch fastener.	Med
W25	Mayor's Parlour	Timber Sliding Sash (Hornless)	1960s replacement	20th Century Single glazing	Appear to be softwood frames. Rot evident to external sill and frames and evidence of previous filler repairs to frames. Protective paint coating deteriorated and flaking.	Sash cords in situ, serviceable. Overpainted. Sash Brighton fastener and retrospective frame locks	Low
W26	Wedding Room Store	Timber Sliding Sash (Hornless)	1960s replacement	20th Century Single glazing	Appear to be softwood frames. Minor rot evident to external sill and frames and evidence of previous filler repairs to frames. Protective paint coating deteriorated and flaking.	Sash cords in situ, serviceable. Overpainted. Sash quadrant arm fastener.	Low

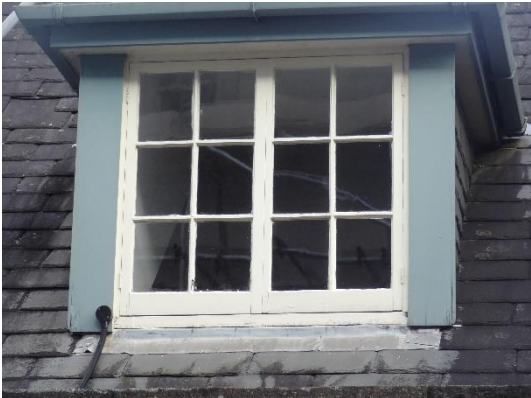
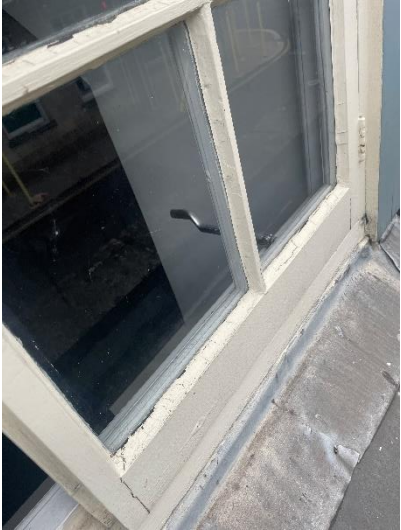
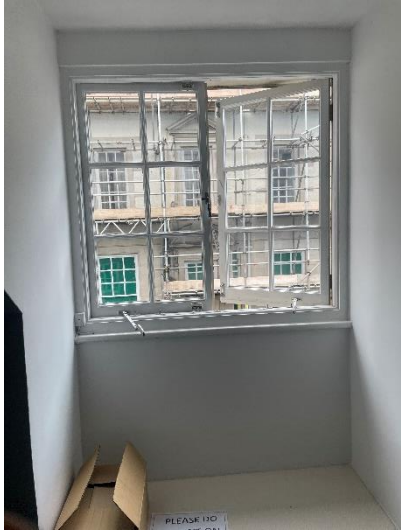
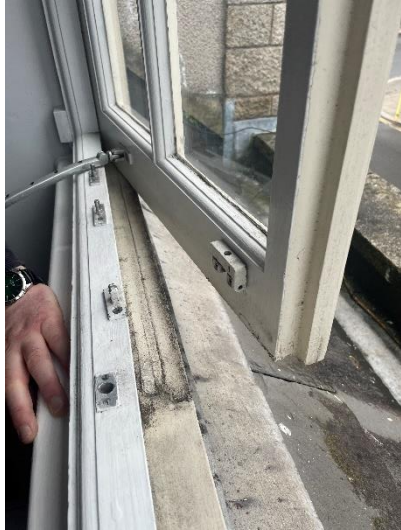
Town Hall, Market Street – Casement Windows 15 &16 - Indicative Sample Photographs

W15	Meeting Room	Timber Casement Window	Late 20th Century, new	20th Century Single glazing (interior obscured by blinds)	Appear to be softwood frames. Frames in serviceable condition with minor decay. Protective paint coating bubbled and flaking.	Casement hinges. Casement handles and non-locking stays. Retrospective casement locks.	Low

W16	Meeting Room	Timber Casement Window	Late 20th Century, new	20th Century Single glazing (interior obscured by blinds)	Appear to be softwood frames. Frames in serviceable condition with minor decay. Protective paint coating bubbled and flaking.	Casement hinges. Casement handles and non-locking stays. Retrospective casement locks.	Low
W17	Archive	Timber Sliding Sash (Hornless)	1960s, new	20th Century Single glazing. Extractor vent to top pane (pane cracked).	Appear to be softwood frames. Frames in serviceable condition with minor decay. Protective paint coating bubbled and flaking.	Sash cords in situ, unable to test. Overpainted. Access not possible but assumed sash weights are present. Sash fitch fastener	Low
W18	NOT USED - NOT REFERENCED ON PLANS						
W19	Archive	Timber Sliding Sash (Hornless)	1960s, new	20th Century Single glazing	Appear to be softwood frames. Frames in serviceable condition with minor decay. Protective paint coating bubbled and flaking.	Sash cords in situ, serviceable. Overpainted. Sash fitch fastener	Low

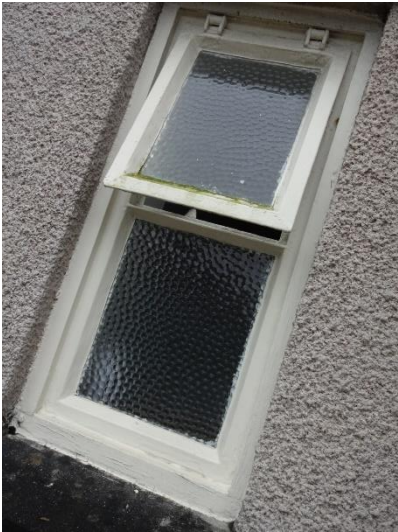
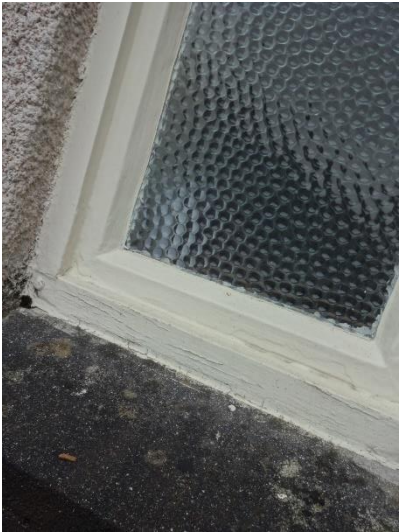
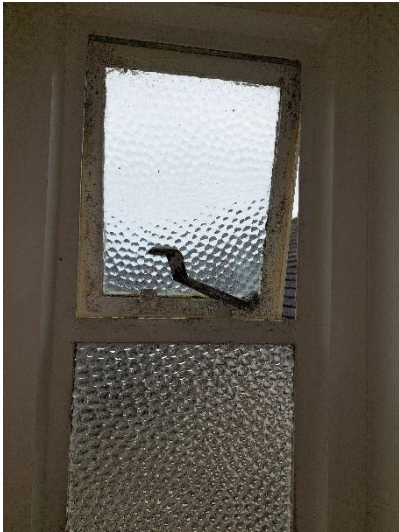
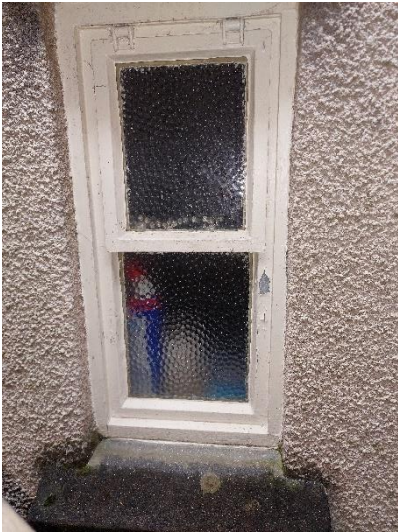
Town Hall, Inner Courtyard – Crittal Windows 27, 28 & 29 - Indicative Sample Photographs

W27	WC	Metal Crittal Window	20th Century	20th Century Single glazing (obscured)	Painted steel crittal frame in painted softwood timber sub-frame. Minor decay of timber sub frame. Protective paint coating to steel frame peeling and deteriorated with mould growth.	Fixed light, top hinged opening light outward opening. Hinges require easing. Casement stay.	Low

W28	WC	Metal Crittal Window	20th Century	20th Century Single glazing (obscured)	Painted steel crittal frame in painted softwood timber sub-frame. Minor decay of timber sub frame. Protective paint coating to steel frame flaking and deteriorated with mould growth.	Fixed light, top hinged opening light outward opening. Hinges require easing. Casement stay.	Low
W29	Corridor	Metal Crittal Window	20th Century	20th Century Single glazing (obscured)	Painted steel crittal frame in painted softwood timber sub-frame. Minor decay of timber sub frame. Protective paint coating to steel frame peeling and deteriorated with mould growth.	Fixed light, top hinged opening light outward opening. Hinges require easing. Casement stay.	Low
W30	Corridor	Timber Sliding Sash (Hornless)	1960s replacement	20th Century Single glazing	Appear to be softwood frames. Minor rot evident to external sill and frames and evidence of previous filler repairs to frames. Protective paint coating deteriorated and flaking.	Sash cords in situ, serviceable. Overpainted. Sash quadrant arm fastener.	Low

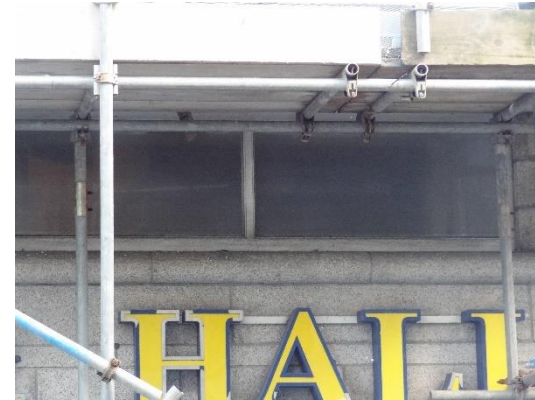
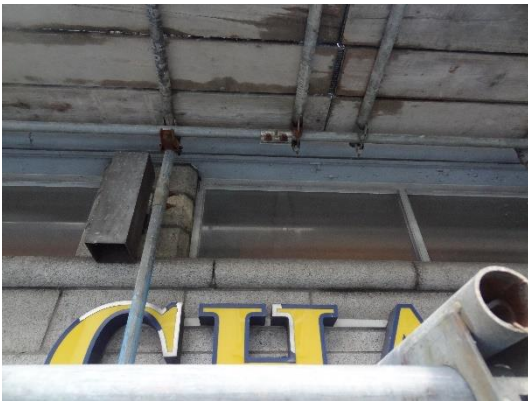
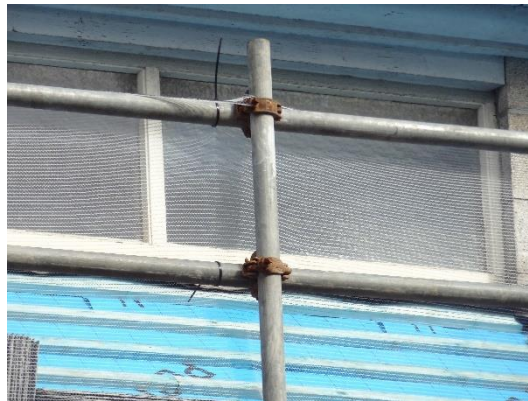
Charter Hall, Market Street – Fixed Light Windows 31-36 & 38 - Indicative Sample Photographs

W31	Charter Hall	Timber Fixed Windows	20th Century	20th Century Single glazing	Appear to be softwood frames. Frames in serviceable condition with minor decay. Protective paint coating bubbled and flaking.	NA	Low

W32	Charter Hall	Timber Fixed Windows	20th Century	20th Century Single glazing	Appear to be softwood frames. Frames in serviceable condition with minor decay. Protective paint coating bubbled and flaking.	NA	Low
W33	Charter Hall	Timber Fixed Windows	20th Century	20th Century Single glazing	Appear to be softwood frames. Frames in serviceable condition with minor decay. Protective paint coating bubbled and flaking.	NA	Low
W34	Charter Hall	Timber Fixed Windows	20th Century	20th Century Single glazing	Appear to be softwood frames. Frames in serviceable condition with minor decay. Protective paint coating bubbled and flaking.	NA	Low
W35	Charter Hall	Timber Fixed Windows	20th Century	20th Century Single glazing	Appear to be softwood frames. Frames in serviceable condition with minor decay. Protective paint coating bubbled and flaking.	NA	Low
W36	Charter Hall	Timber Fixed Windows	20th Century	20th Century Single glazing	Appear to be softwood frames. Frames in serviceable condition with minor decay. Protective paint coating bubbled and flaking.	NA	Low

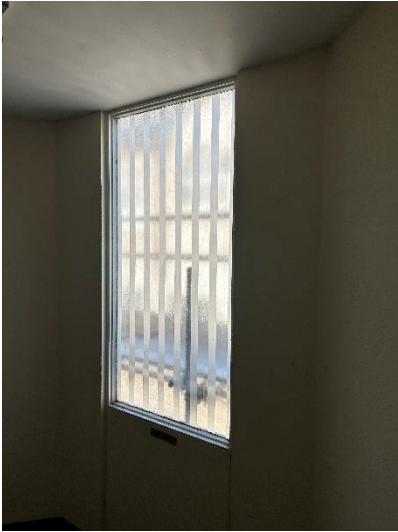
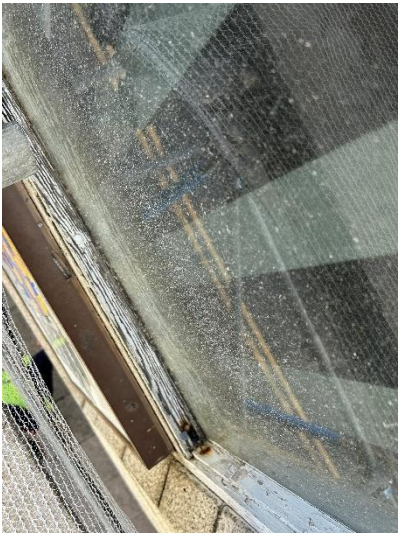
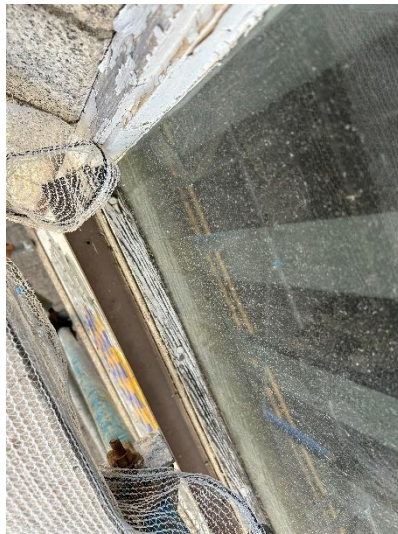
Charter Hall, Market Street – Fixed Light Windows 37 - Indicative Sample Photographs

W37	Cinema Foyer	Timber Fixed Windows	20th Century	20th Century Single glazing (plastic coating)	Appear to be softwood frames. Minor rot evident to external sill and frames. Protective paint coating deteriorated and flaking.	NA	Med
W38	Cinema Foyer	Timber Fixed Windows	20th Century	20th Century Single glazing	Appear to be softwood frames. Frames in serviceable condition with minor decay. Protective paint coating bubbled and flaking.	NA	Low
W39	Cinema Foyer	Metal Crittal Window	20th Century	20th Century Single glazing	Painted steel crittal frame in painted softwood timber sub-frame. Minor decay of timber sub frame. Protective paint coating to steel frame poor and deteriorated .	Central pivot hinge - ceased, inoperable	Med
W40	Cinema Foyer	Timber Casement Windows	20th Century	20th Century Single glazing	Painted steel crittal frame in painted softwood timber sub-frame. Minor decay of timber sub frame. Protective paint coating to steel frame poor and deteriorated .	Central pivot hinge - ceased, inoperable	Med

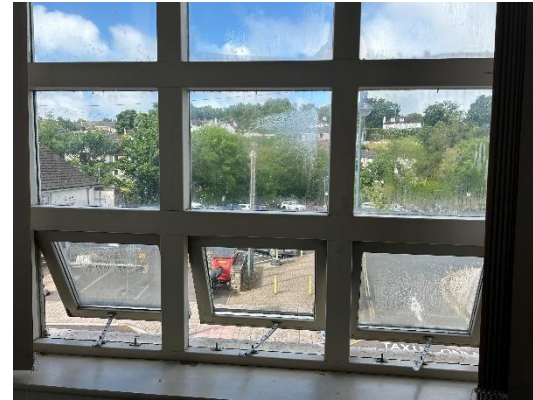
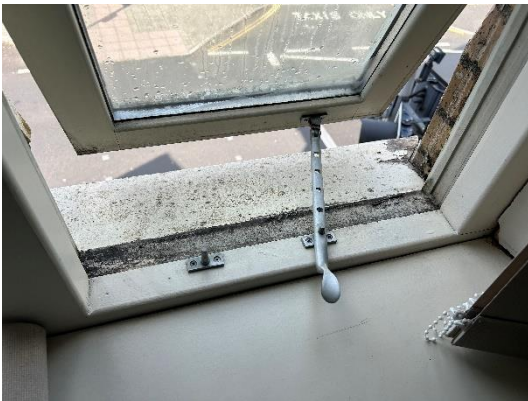
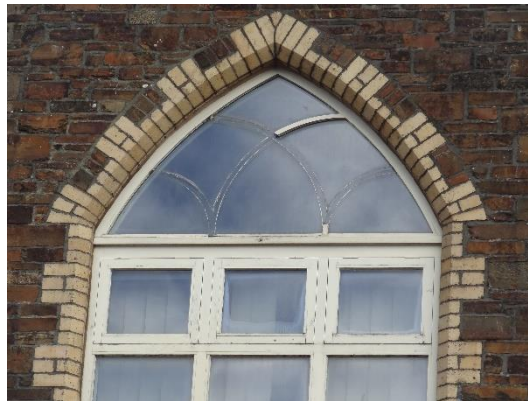
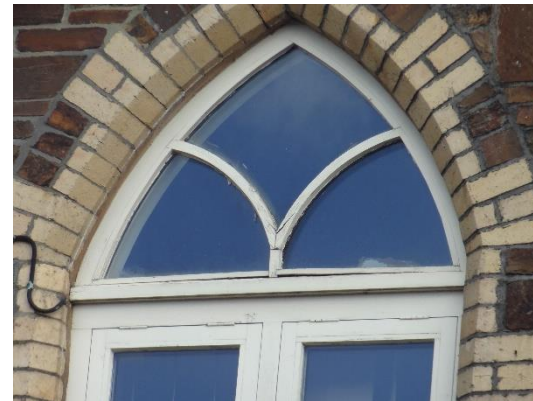
Lower Market Hall, Market Street – Casement Windows 41-43 - Indicative Sample Photographs

W41	Lower Market Hall	Timber Casement Windows with arched fixed light over	20th Century	20th Century Double glazing Unit seals failed, condensation between panes	Appear to be hardwood frames. Thick timber sections, amateur construction. Frames in serviceable condition with minor decay. Decorative glazing bars to fixed light missing/detached. Protective paint coating bubbled and flaking.	Hinges, serviceable. Casement handles and non-locking stays.	Med
W42	Lower Market Hall	Timber Casement Windows with arched fixed light over	20th Century	20th Century Double glazing Unit seals failed, condensation between panes	Appear to be hardwood frames. Thick timber sections, amateur construction. Frames in serviceable condition with minor decay. Decorative glazing bars to fixed light missing/detached. Protective paint coating bubbled and flaking.	Hinges, serviceable. Casement handles and non-locking stays.	Med

W43	Lower Market Hall	Timber Casement Windows with arched fixed light over	20th Century	20th Century Double glazing Unit seals failed, condensation between panes	Appear to be hardwood frames. Thick timber sections, amateur construction. Frames in serviceable condition with minor decay. Decorative glazing bars to fixed light missing/detached. Protective paint coating bubbled and flaking.	Hinges, serviceable. Casement handles and non-locking stays.	Med

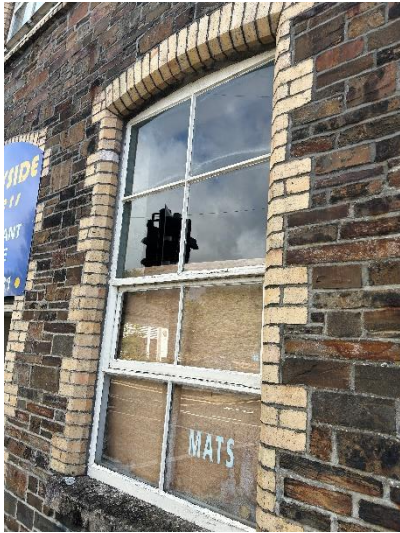
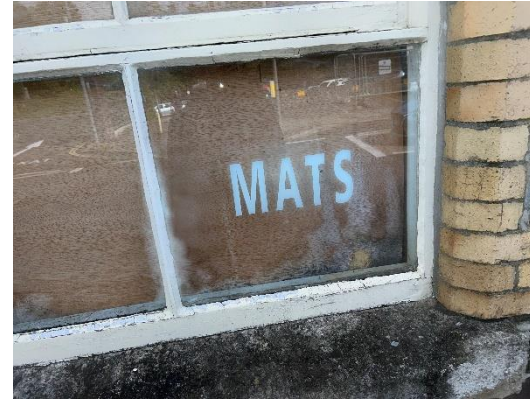
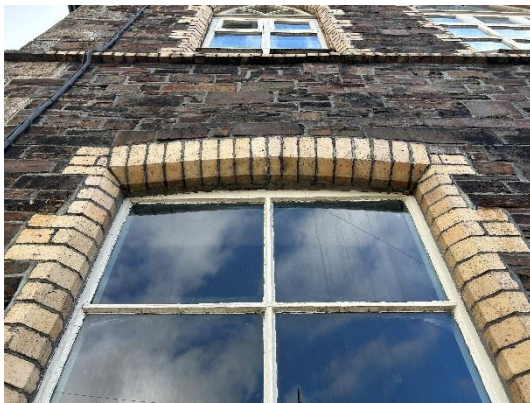
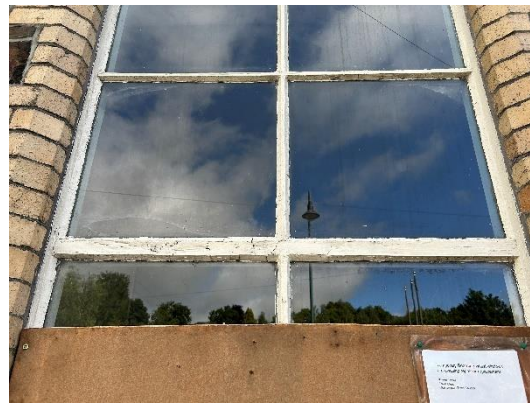
Lower Market Hall, Market Street – Fixed & Casement Windows 44 & 45 - Indicative Sample Photographs

W44	Lower Market Hall	Timber Fixed Light Window	Early 20th Century	20th Century Single glazing Broken glazing to lower half - risk as at street level and boarded externally	Appear to be softwood frames. Frames in poor condition with significant external rot evident and evidence of previous repairs. Protective paint coating deteriorated and flaking.	NA	Urgent
W45	Lower Market Hall	Timber Fixed Light and Casement Window	Early 20th Century	20th Century Single glazing	Appear to be softwood frames. Frames in poor condition with significant external rot evident and evidence of previous repairs. Protective paint coating deteriorated and flaking.	Unable to access internally due to boarding	High
W46	Lower Market Hall	Fixed Light Window	20th Century	20th Century Single glazing	Appear to be softwood frames. Minor rot evident to external frame. Protective paint coating deteriorated and flaking.	NA	Low
W47	Lower Market Hall	Timber Casement Windows	20th Century	20th Century Single glazing	Appear to be softwood frames. Rot evident to external frame. Protective paint coating deteriorated and flaking.	Hinges, require easing.. Casement handles and non-locking stays.	Med

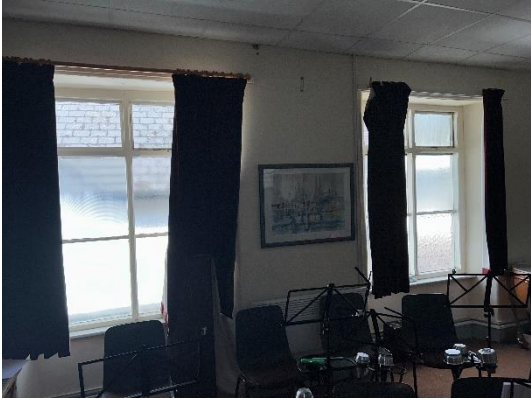
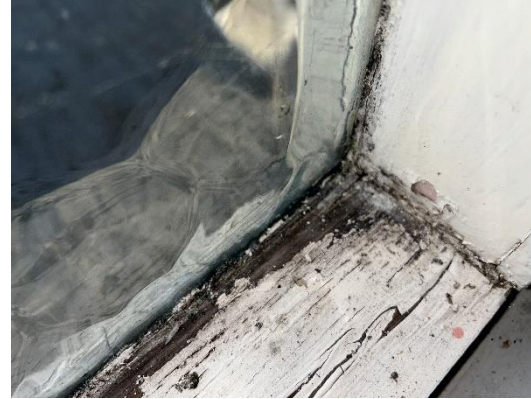
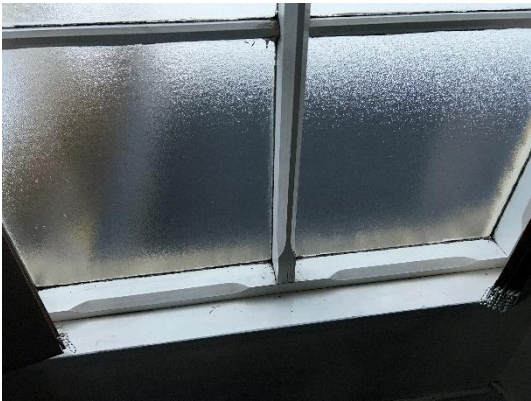
Lower Market Hall, Walkway – Fixed and Casement Windows 46-49 - Indicative Sample Photographs

W48	Lower Market Hall	Timber Casement Windows	20th Century	20th Century Single glazing	Appear to be softwood frames. Rot evident to external frame.	Hinges, require easing.. Casement handles and non-locking stays.	Med

Protective paint coating deteriorated and flaking.		
W49	Lower Market Hall	Fixed Light Window	20th Century	20th Century Single glazing	Appear to be softwood frames. Minor rot evident to external frame. Protective paint coating deteriorated and flaking.	NA	Low
W50	Lower Market Hall (Band Hall inner)	Timber Casement Windows	20th Century	20th Century Single glazing	Appear to be softwood frames. Rot evident to external frame and large previous filler repair. Protective paint coating deteriorated and flaking.	Hinges, serviceable.	Med
W51	Archive	Timber Casement Windows	20th Century	20th Century Single glazing	Appear to be softwood frames. Rot evident to external sill and frame. Protective paint coating deteriorated.	Hinges, ceased/timber swollen and unable to open. Casement handles and non-locking stays.	Low
W52	Archive	Timber Sliding Sash (Hornless)	20th Century	20th Century Single glazing	Appear to be softwood frames. Rot evident to external sill and frames and evidence of previous filler repairs to frames. Protective paint coating deteriorated and flaking.	Sash cords in situ, serviceable. Overpainted. Sash Brighton fastener.	Med
