Window Condition Schedule & Photographs

Okehampton Town Hall,
Charter Hall &
Lower Market Hall

Window Condition Schedule

Survey Dates - 22nd March 2024 and 14th June 2024

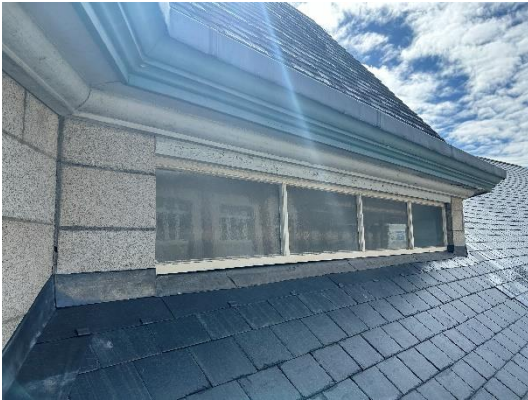
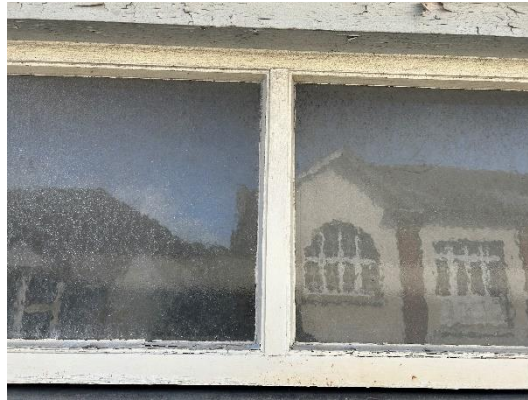
Charter Hall, Market Street – Fixed Light Windows 31-36 & 38 - Indicative Sample Photographs

W31	Charter Hall	Timber Fixed Windows	20th Century	20th Century Single glazing	Appear to be softwood frames. Frames in serviceable condition with minor decay. Protective paint coating bubbled and flaking.	NA	Low

W32	Charter Hall	Timber Fixed Windows	20th Century	20th Century Single glazing	Appear to be softwood frames. Frames in serviceable condition with minor decay. Protective paint coating bubbled and flaking.	NA	Low
W33	Charter Hall	Timber Fixed Windows	20th Century	20th Century Single glazing	Appear to be softwood frames. Frames in serviceable condition with minor decay. Protective paint coating bubbled and flaking.	NA	Low
W34	Charter Hall	Timber Fixed Windows	20th Century	20th Century Single glazing	Appear to be softwood frames. Frames in serviceable condition with minor decay. Protective paint coating bubbled and flaking.	NA	Low
W35	Charter Hall	Timber Fixed Windows	20th Century	20th Century Single glazing	Appear to be softwood frames. Frames in serviceable condition with minor decay. Protective paint coating bubbled and flaking.	NA	Low
W36	Charter Hall	Timber Fixed Windows	20th Century	20th Century Single glazing	Appear to be softwood frames. Frames in serviceable condition with minor decay. Protective paint coating bubbled and flaking.	NA	Low

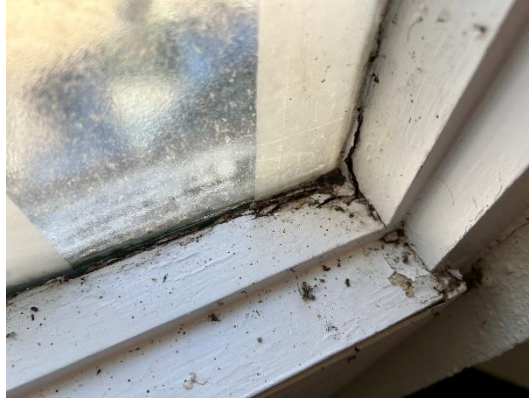
Charter Hall, Market Street – Fixed Light Windows 37 - Indicative Sample Photographs

W37	Cinema Foyer	Timber Fixed Windows	20th Century	20th Century Single glazing (plastic coating)	Appear to be softwood frames. Minor rot evident to external sill and frames. Protective paint coating deteriorated and flaking.	NA	Med
W38	Cinema Foyer	Timber Fixed Windows	20th Century	20th Century Single glazing	Appear to be softwood frames. Frames in serviceable condition with minor decay. Protective paint coating bubbled and flaking.	NA	Low
W39	Cinema Foyer	Metal Crittal Window	20th Century	20th Century Single glazing	Painted steel crittal frame in painted softwood timber sub-frame. Minor decay of timber sub frame. Protective paint coating to steel frame poor and deteriorated .	Central pivot hinge - ceased, inoperable	Med
W40	Cinema Foyer	Timber Casement Windows	20th Century	20th Century Single glazing	Painted steel crittal frame in painted softwood timber sub-frame. Minor decay of timber sub frame. Protective paint coating to steel frame poor and deteriorated .	Central pivot hinge - ceased, inoperable	Med

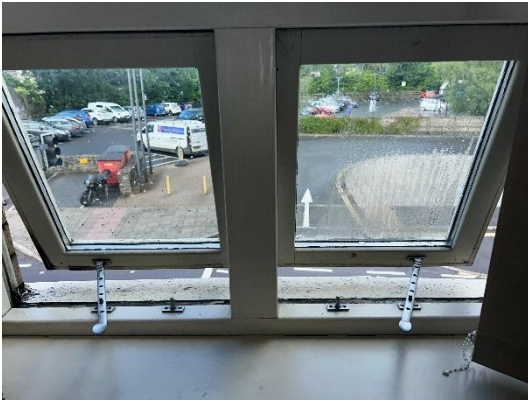
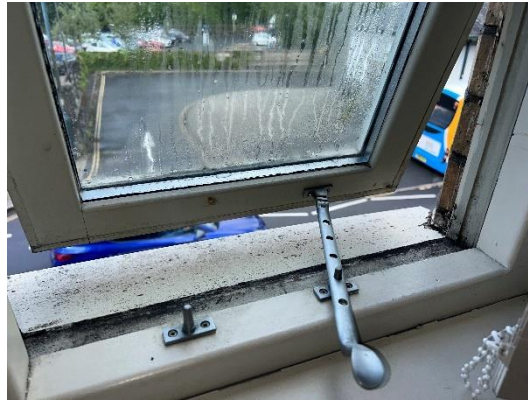
Lower Market Hall, Market Street – Casement Windows 41-43 - Indicative Sample Photographs

W41	Lower Market Hall	Timber Casement Windows with arched fixed light over	20th Century	20th Century Double glazing Unit seals failed, condensation between panes	Appear to be hardwood frames. Thick timber sections, amateur construction. Frames in serviceable condition with minor decay. Decorative glazing bars to fixed light missing/detached. Protective paint coating bubbled and flaking.	Hinges, serviceable. Casement handles and non-locking stays.	Med
W42	Lower Market Hall	Timber Casement Windows with arched fixed light over	20th Century	20th Century Double glazing Unit seals failed, condensation between panes	Appear to be hardwood frames. Thick timber sections, amateur construction. Frames in serviceable condition with minor decay. Decorative glazing bars to fixed light missing/detached. Protective paint coating bubbled and flaking.	Hinges, serviceable. Casement handles and non-locking stays.	Med

W43	Lower Market Hall	Timber Casement Windows with arched fixed light over	20th Century	20th Century Double glazing Unit seals failed, condensation between panes	Appear to be hardwood frames. Thick timber sections, amateur construction. Frames in serviceable condition with minor decay. Decorative glazing bars to fixed light missing/detached. Protective paint coating bubbled and flaking.	Hinges, serviceable. Casement handles and non-locking stays.	Med

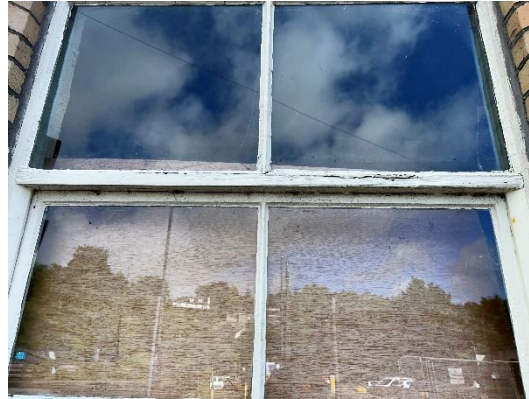
Lower Market Hall, Market Street – Fixed & Casement Windows 44 & 45 - Indicative Sample Photographs

W44	Lower Market Hall	Timber Fixed Light Window	Early 20th Century	20th Century Single glazing Broken glazing to lower half - risk as at street level and boarded externally	Appear to be softwood frames. Frames in poor condition with significant external rot evident and evidence of previous repairs. Protective paint coating deteriorated and flaking.	NA	Urgent
W45	Lower Market Hall	Timber Fixed Light and Casement Window	Early 20th Century	20th Century Single glazing	Appear to be softwood frames. Frames in poor condition with significant external rot evident and evidence of previous repairs. Protective paint coating deteriorated and flaking.	Unable to access internally due to boarding	High
W46	Lower Market Hall	Fixed Light Window	20th Century	20th Century Single glazing	Appear to be softwood frames. Minor rot evident to external frame. Protective paint coating deteriorated and flaking.	NA	Low
W47	Lower Market Hall	Timber Casement Windows	20th Century	20th Century Single glazing	Appear to be softwood frames. Rot evident to external frame. Protective paint coating deteriorated and flaking.	Hinges, require easing.. Casement handles and non-locking stays.	Med

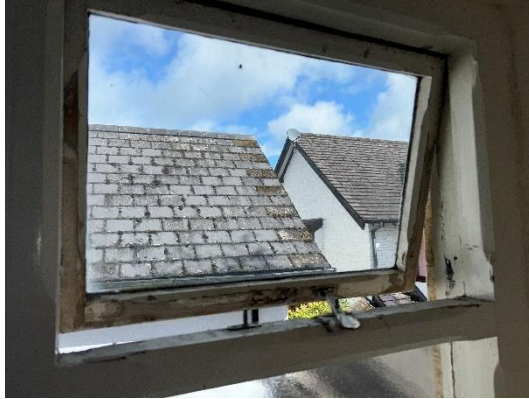
Lower Market Hall, Walkway – Fixed and Casement Windows 46-49 - Indicative Sample Photographs

W48	Lower Market Hall	Timber Casement Windows	20th Century	20th Century Single glazing	Appear to be softwood frames. Rot evident to external frame.	Hinges, require easing.. Casement handles and non-locking stays.	Med

Protective paint coating deteriorated and flaking.		
W49	Lower Market Hall	Fixed Light Window	20th Century	20th Century Single glazing	Appear to be softwood frames. Minor rot evident to external frame. Protective paint coating deteriorated and flaking.	NA	Low
W50	Lower Market Hall (Band Hall inner)	Timber Casement Windows	20th Century	20th Century Single glazing	Appear to be softwood frames. Rot evident to external frame and large previous filler repair. Protective paint coating deteriorated and flaking.	Hinges, serviceable.	Med
W51	Archive	Timber Casement Windows	20th Century	20th Century Single glazing	Appear to be softwood frames. Rot evident to external sill and frame. Protective paint coating deteriorated.	Hinges, ceased/timber swollen and unable to open. Casement handles and non-locking stays.	Low
W52	Archive	Timber Sliding Sash (Hornless)	20th Century	20th Century Single glazing	Appear to be softwood frames. Rot evident to external sill and frames and evidence of previous filler repairs to frames. Protective paint coating deteriorated and flaking.	Sash cords in situ, serviceable. Overpainted. Sash Brighton fastener.	Med
